## **NAVAL AIR ENGINEERING CENTER**

REPORT NAEC-92-171

### **PREDICTION OF HYDRAULIC PUMP FAILURES THROUGH WEAR DEBRIS ANALYSIS**

19 July 1983

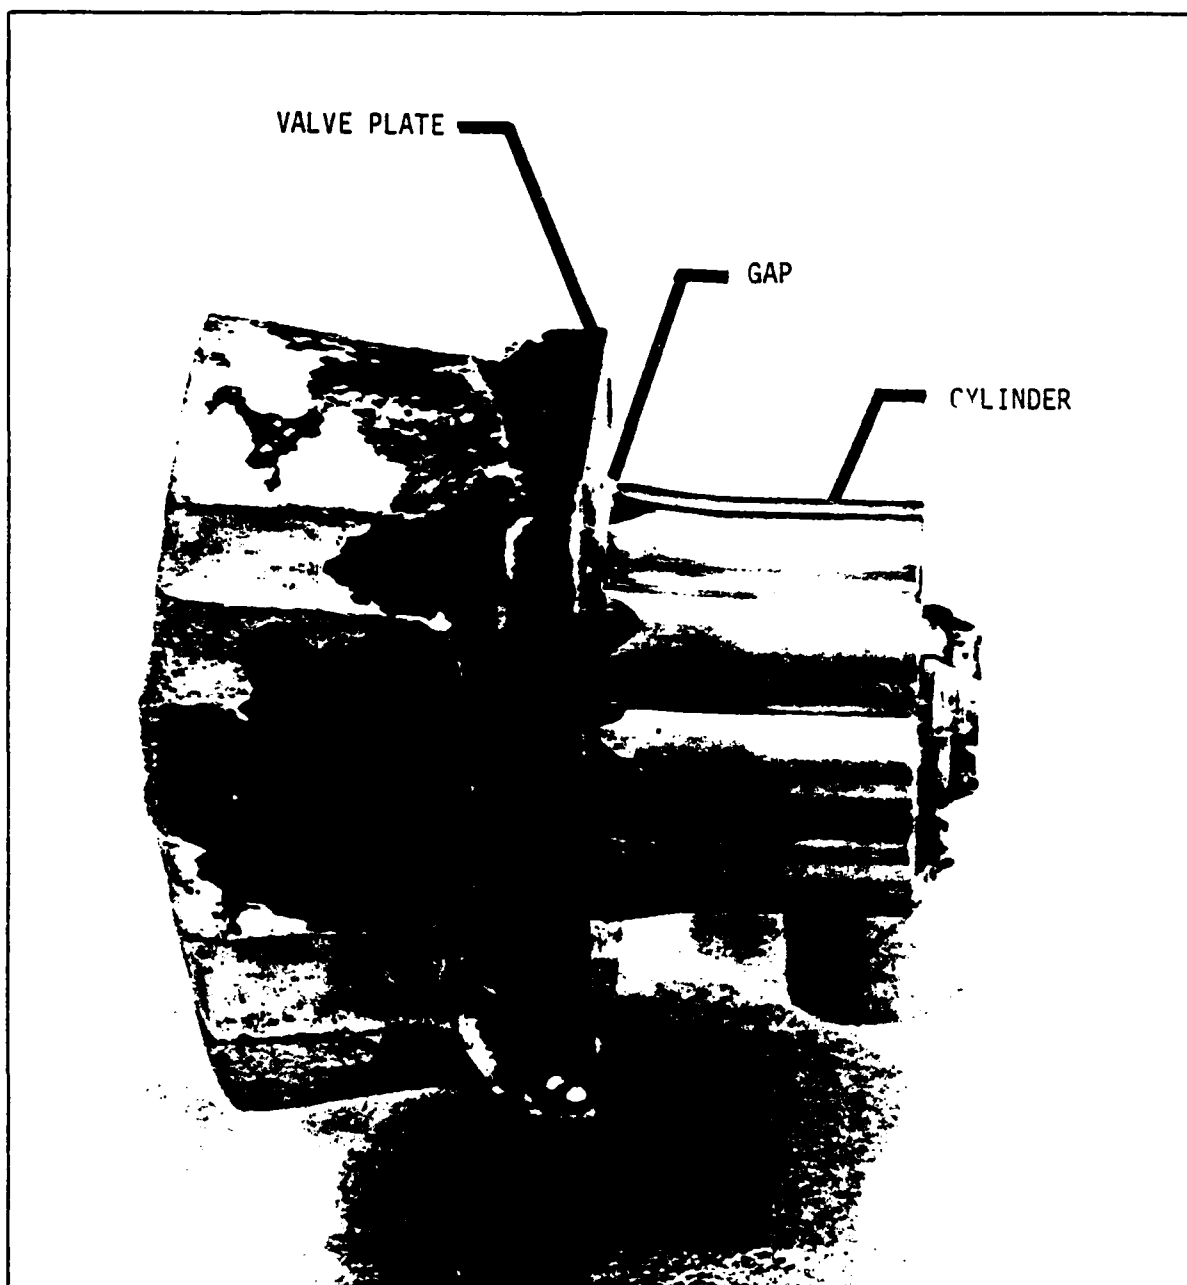
Figure 6 - Failed Motor Valve Plate  
and Cylinder Gap

3. Disassembly of the hydraulic motor portion of the unit revealed a gap between the valve plate and cylinder block, Figure 6, which allowed 3,000 psi fluid flow to bypass the motor pistons, resulting in an inoperative unit. Further disassembly of the cylinder block subassembly, Figures

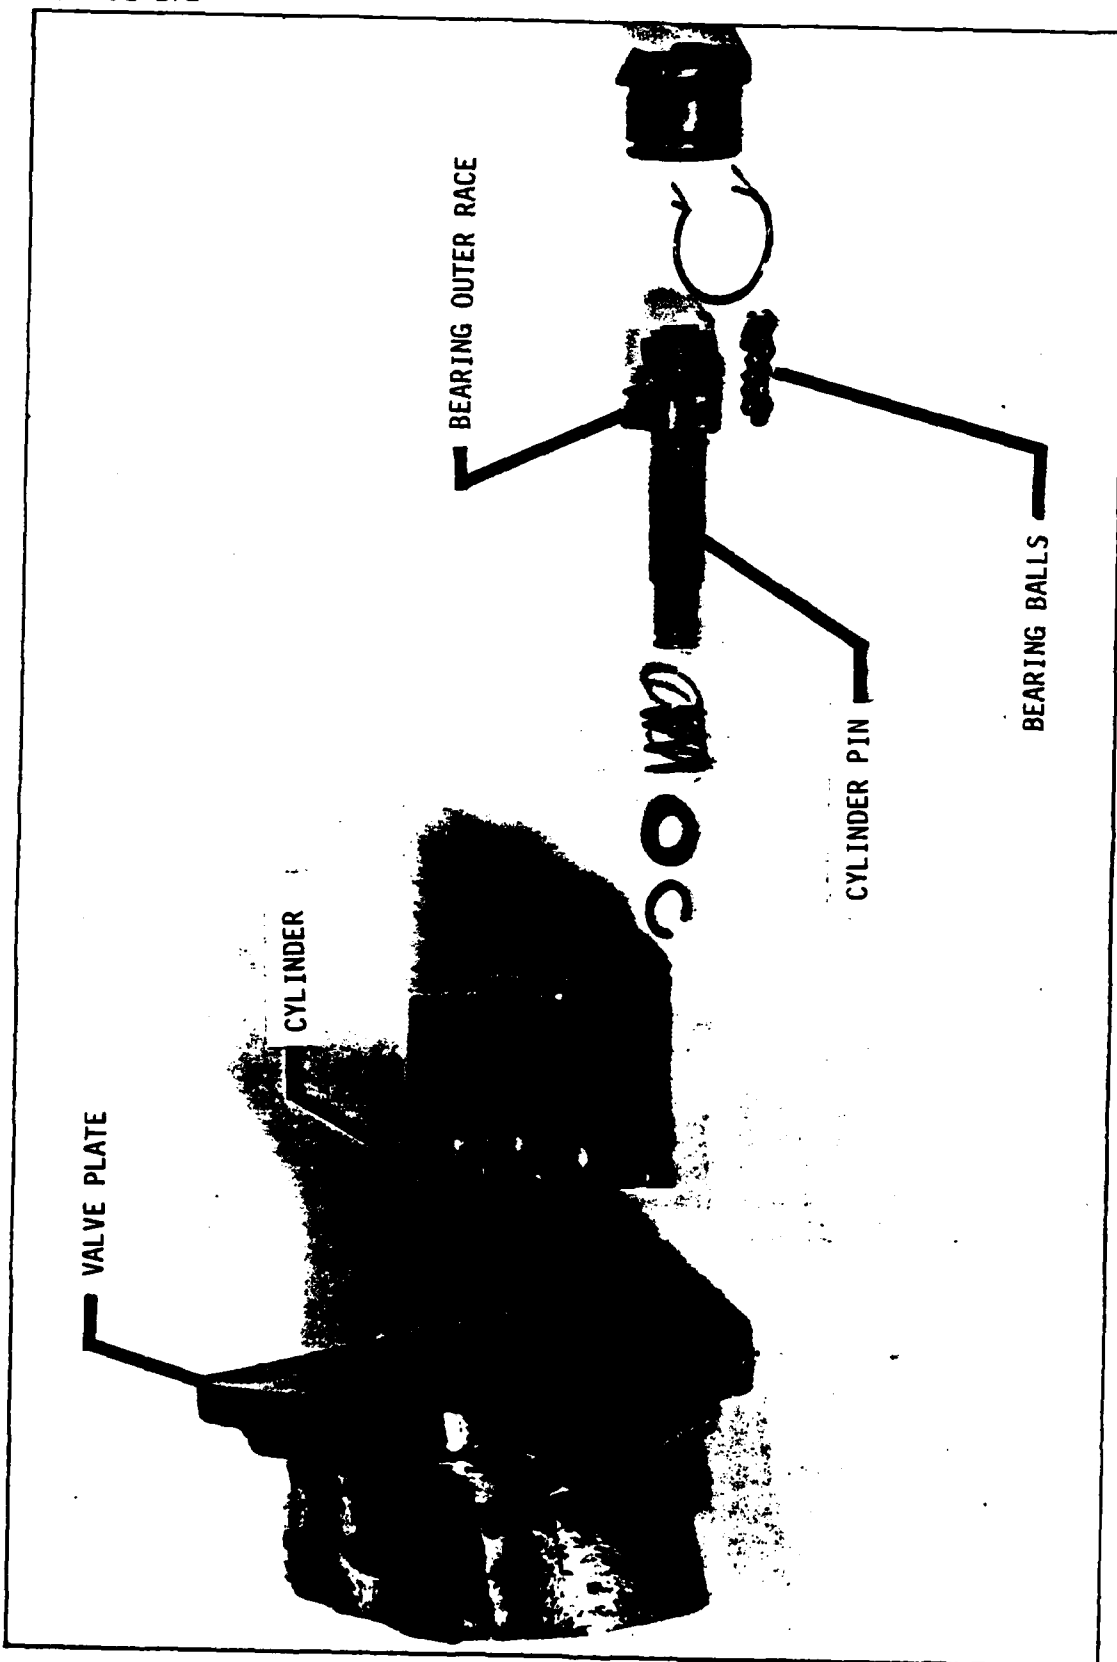
Figure 7 - Disassembled Valve Plate and Cylinder Assembly

7 and 8, revealed that the valve plate and cylinder block gap resulted from a failed nonmetallic retainer for the balls in the cylinder block pin bearing. Failure of the retainer allowed the balls to escape from the bearing race, permitting free-play and gaps between the cylinder block and valve plate. Metallurgical analysis revealed galling of the bearing race, material fretting on the cylinder pin (Figure 9), and spalling of the bearing balls (Figure 10). The cylinder block, valve plate, and pistons from the failed unit are shown in Figure 11.

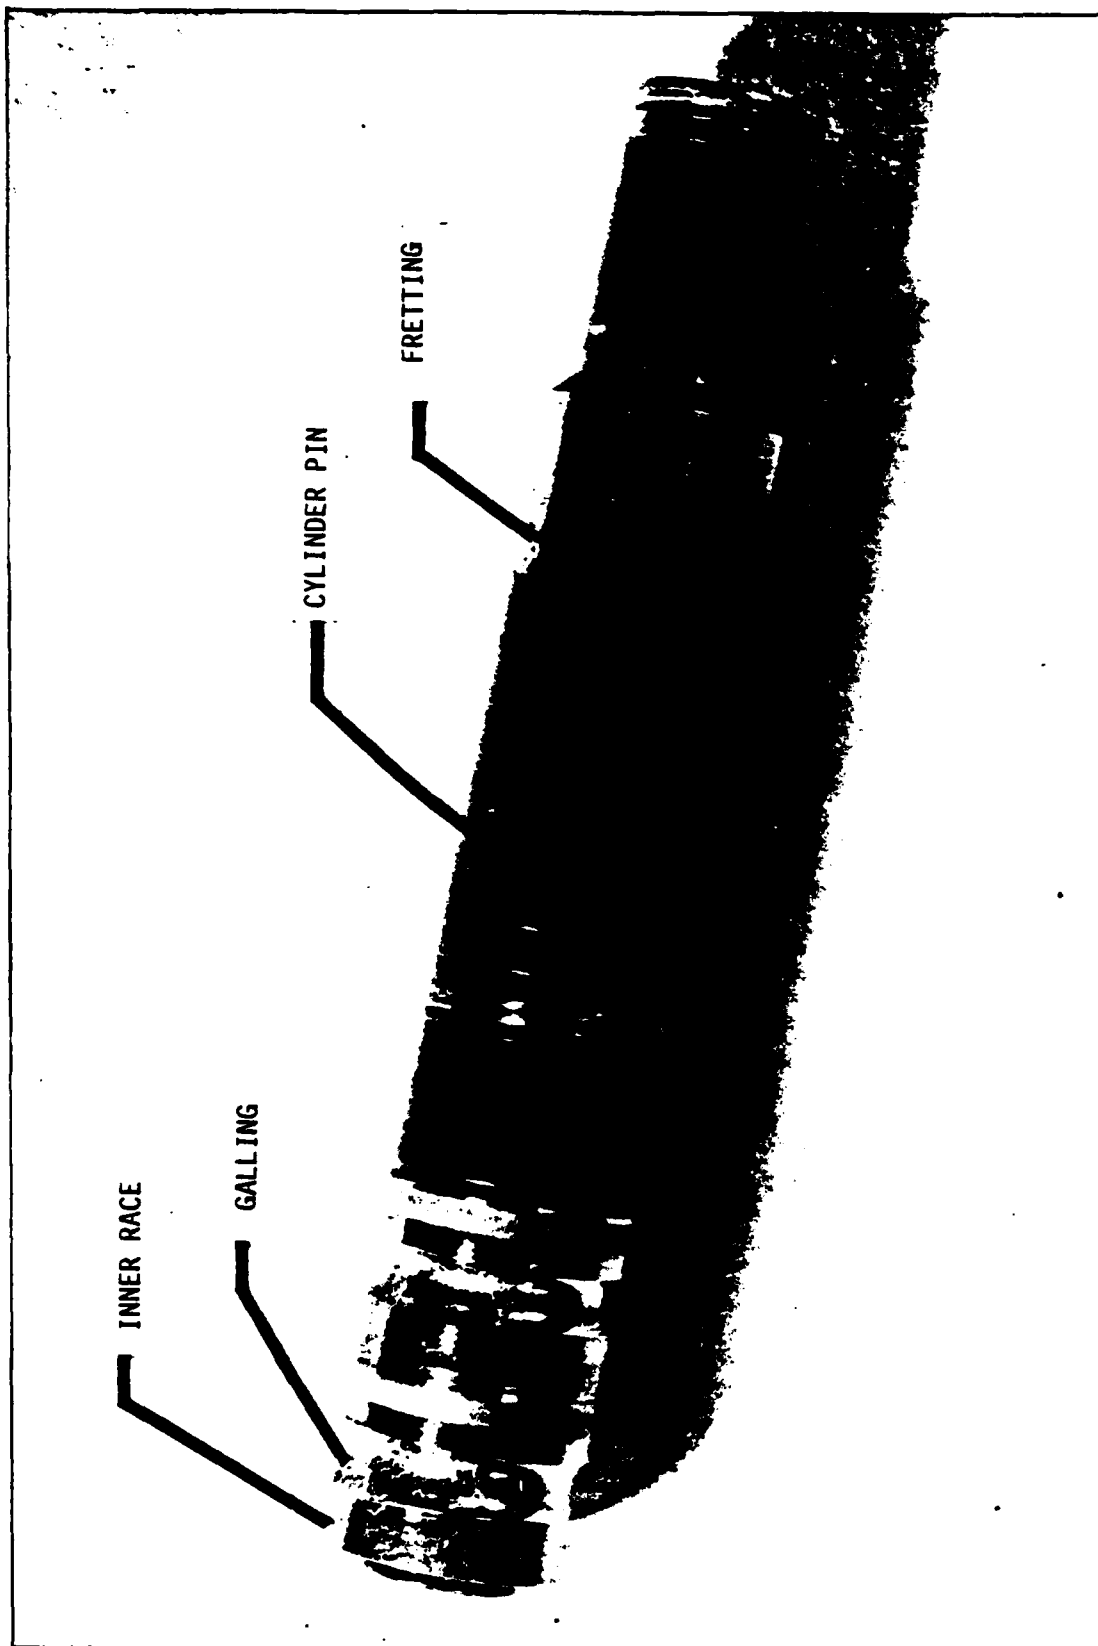
Figure 9 - Galled Surface of Bearing Inner Race

4. It was not apparent whether spalling of bearing balls or galling of the bearing race occurred prior to the ball retainer failure. The failed hydraulic motor is in the filtered system.
